The State of Onondaga Creek

FACT SHEETS

Onondaga Creek Fact Sheets

The **State of Onondaga Creek Fact Sheets** were produced by Onondaga Environmental Institute as a work product of the Onondaga Creek Conceptual Revitalization Plan Project (OCRCP).

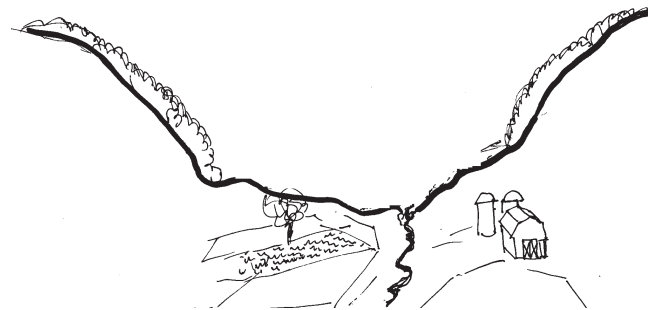
TULLY VALLEY

Tully Valley and its uplands contain the south (or east) branch of the creek. In the southern part of the valley, deep rich soil of the valley floor supports dairy farms and field crops, and in the northern part of the valley, fruit orchards and wetlands are adjacent to the creek. Valley walls are typically forested. At the southern end of the valley, the valley walls and bedrock beneath them contain fractures that resulted from the former brine well operations. North of the Valley Heads moraine, a section of the valley floor has sunk from the salt removal that occurred beneath it. The uplands of the Tully Valley have mixed use, with hill-top farms, exurban homes, patches of woodlot forest, apple orchards, and upland wetlands. Surface geologic features include the terminal glacial moraine at Tully, hills that are part of the Appalachian Plateau,

mining land subsidence across the upper Tully Valley, active landslides in the Rainbow Creek and Rattlesnake Gulf tributaries, mudboils in the valley floor near Otisco Road, and infrequent landslides along the main valley's walls. Tributary streams fall steeply from forested hanging valleys, providing the cool water, oxygenation and gravelly stream bottoms that are appropriate for trout existence and in some cases, trout spawning.

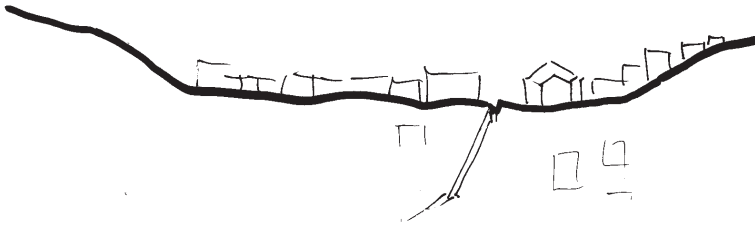
CITY OF SYRACUSE

The City of Syracuse occupies the lowest section of Onondaga Valley and nearby uplands. The oldest part of the city, now a financial, governmental and cultural area, centers on a former wetland of the creek. To the east and west rise sloped valley walls with several carbonate-bedrock sourced natural springs¹ and tributaries located in forest “islands” among residential housing and local businesses. The City of Syracuse is on the edge of the Appalachian Plateau to the south, and the city includes the southern edge of Onondaga Lake in the edge of the Ontario Lake Plain to the north.

Before the city developed, the creek formed many meanders on the flat land, and frequently flooded the area. The creek bottom and banks have been redesigned to provide straight, smooth, and fast flow, with the capacity to contain most flows within its banks. Runoff from the cityscape is very rapid due to hard surfaces, little vegetation or soft ground, many slopes, and drains that minimize ponding. (See water quality and hydrology fact sheets)

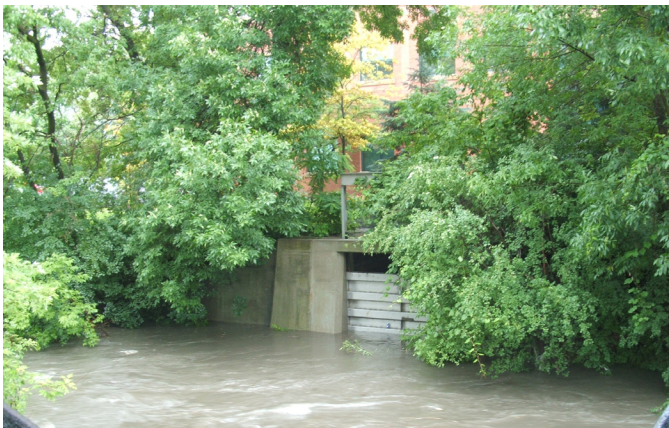
Figure 7. Onondaga Creek at pedestrian bridge upstream of Spencer Street on July 12, 2006, about 1pm.

Note: Flow ~1100 cfs, and depth = 5.7 ft. The peak flow occurred at 5 pm with a flow of 2230 cfs (a 2-year flood).

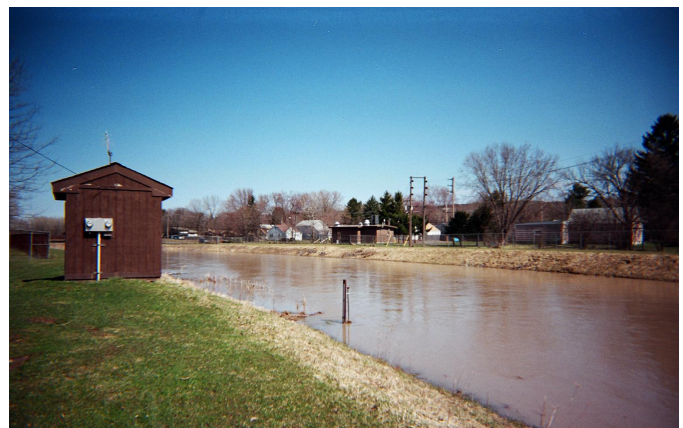
Figure 8. Creek at Dorwin Ave gage station, April 5, 2005

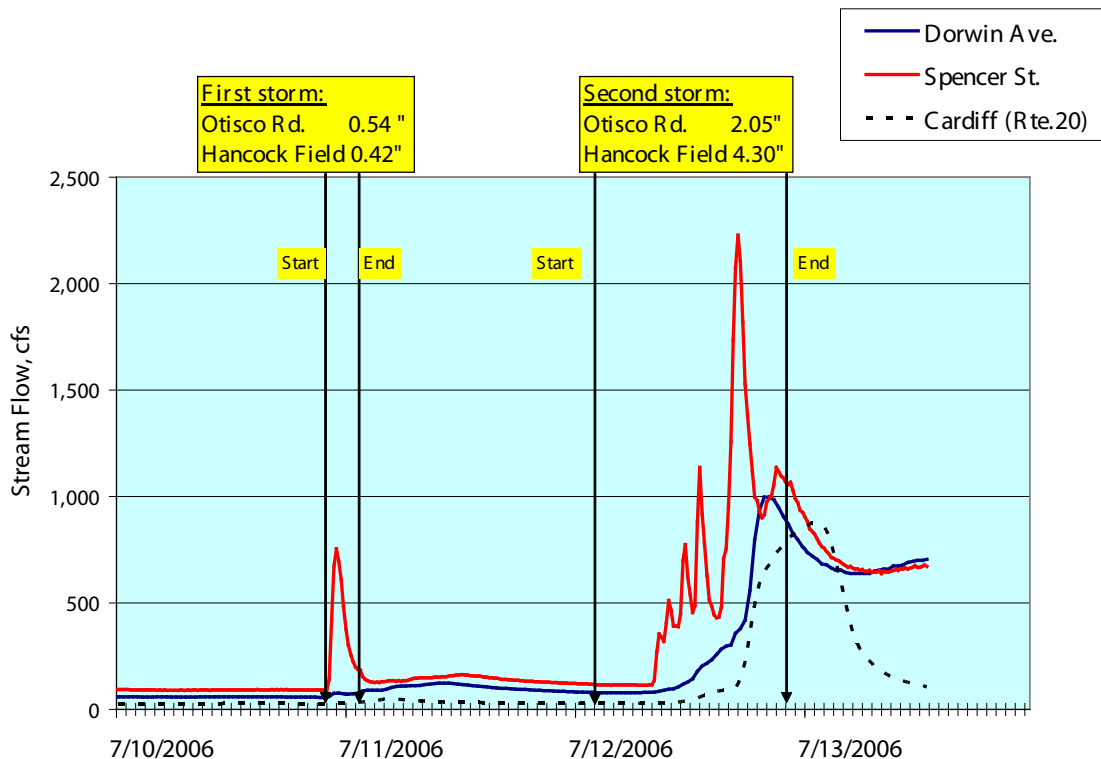
Figure 9. Hydrographs from Onondaga Creek at Cardiff, Dorwin Ave, and Spencer Street

- At Otisco Road (mud boil area), it begins raining about 10pm on July 10th. 0.48 inch falls during the first hour; another 0.06 inch during the next two hours. Total = 0.54 inch
- Creek starts rising almost immediately.
 - Base flow = 31 cfs
 - First increase (0.7 cfs) noted at 10:30pm
 - Maximum flow (54 cfs) at 4:15-4:45 am, July 11th
 - Returns to almost base flow (32 cfs) by 2 am, July 12th
- Total volume discharged (above base flow) = 710,000 cubic feet.
- It is difficult to know how much rain fell across the watershed upstream of Route 20 without analyzing meteorological radar data.² As a crude estimate, one could assume 0.54 inch fell across the whole drainage area. On this basis, about 42 million cubic feet of rain fell during this one storm, of which <2% was observed in the creek at Route 20.

- Stream flow at Spencer is very “spiky.” This is due to the urban character of the watershed; in particular the presence of CSOs (Combined Sewer Overflows) and storm sewers which empty into the creek
- Stream flow at Dorwin exhibits a normal hydrograph under moderate flow conditions (first storm), but shows the influence of the upstream dam during the second storm. Flow does not return to pre-storm conditions for an extended period of time because water is stored behind the dam. This effect is also seen at Spencer St. Dorwin does not show sharp spikes since it is upstream of nearly all urban drainage.
- Stream flow at Cardiff (Route 20) exhibits normal hydrographs during both storms.

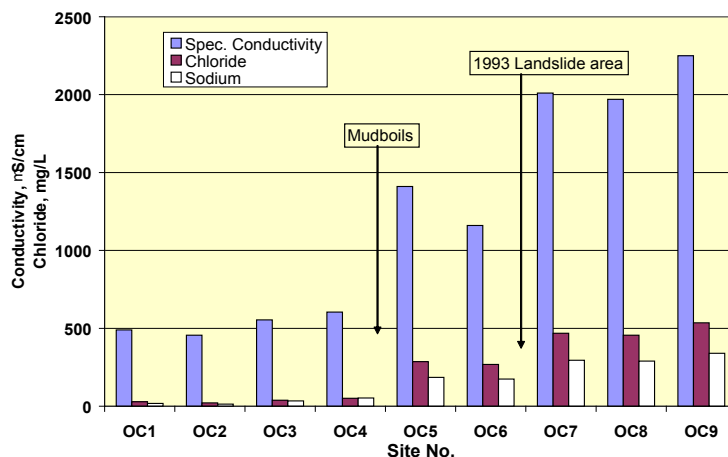
Figure 3A. Specific conductivity, sodium and chloride concentrations in the Tully Valley on July 20, 1998. (USGS web site waterdata.usgs.gov/nwis)

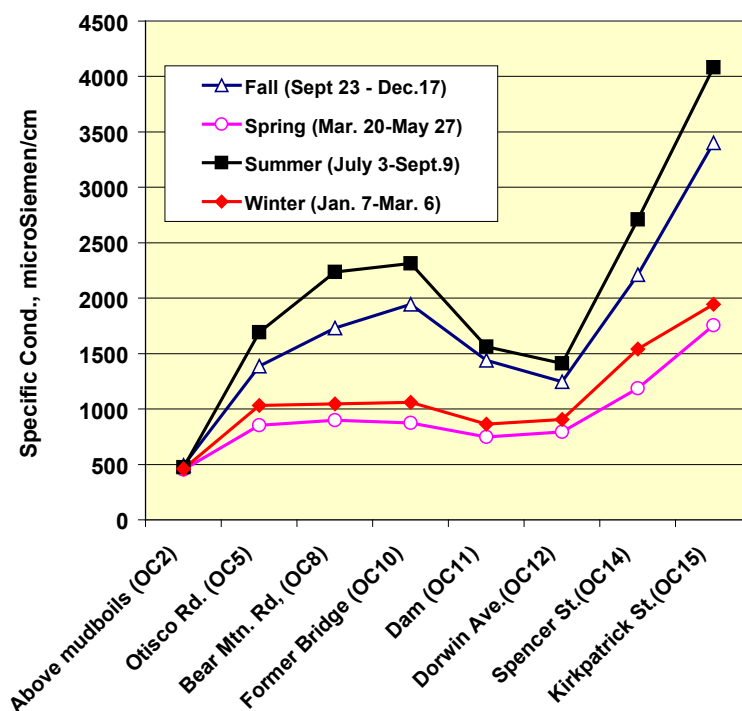
FIGURE 3B. Seasonal averages of specific conductance along Onondaga Creek. (UFI, 2004)

Salinity concentration increases again due to highly saline groundwater discharge to Onondaga Creek in the Spencer and Kirkpatrick area. It should be noted that salt springs have historically been present where the creek enters Onondaga Lake. As such, it seems likely that indigenous organisms, at least in these areas, are tolerant of elevated salinity.

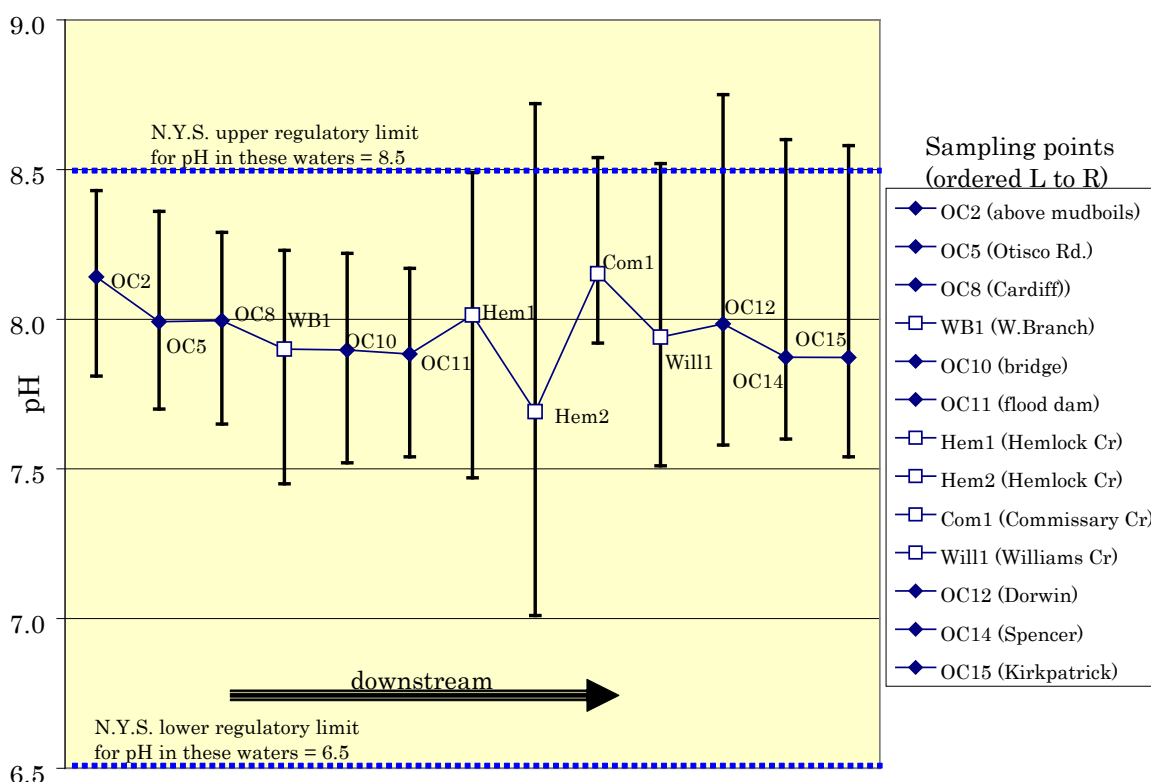
Figure 4. Average pH measured at eight locations along Onondaga Creek, and four tributaries from July 3, 2002-May 23, 2003. Error bars indicate maximum and minimum observations. (UFI, 2004)

The Onondaga Creek watershed has a higher than normal amount of carbonate-enriched glacial sediments due to erosion of limestone bedrock in the north-central part of the Onondaga Creek valley (roughly Nedrow through the Onondaga Hill area), which gives the water relatively high concentrations of bicarbonate. As a result, the water is somewhat alkaline, with pH typically in the range 7.5 – 8.7, and an overall average of 8.0 (UFI, 2004). Figure 4 shows average, minimum, and maximum pH values measured throughout the watershed.

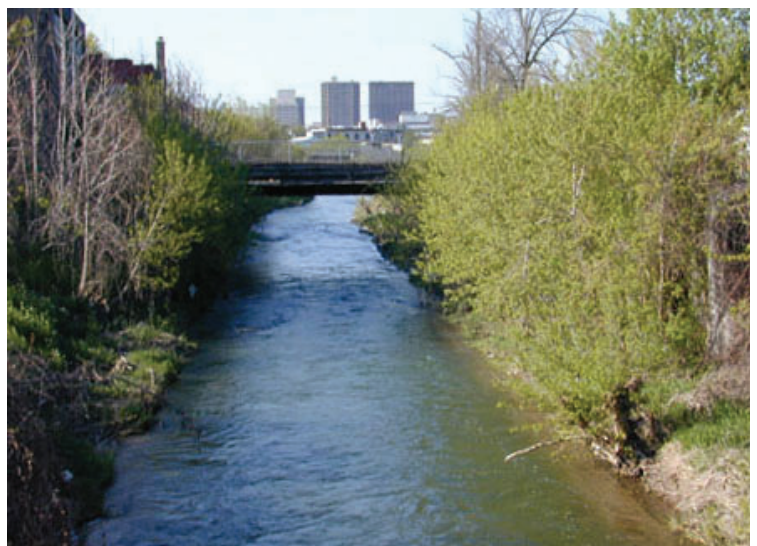
Figure 2. Urban Reach of Onondaga Creek
(Courtesy of Atlantic States Legal Foundation)

1. Channelization is associated with flood control in Syracuse, drainage in agricultural areas, and flow control around and through structures such as bridges and the dam on the Onondaga Nation territory. Habitat surveys have identified channelized reaches throughout the urban lower creek (Figure 2), much of which is further degraded by a concrete liner. Unlined channels in agricultural areas are associated with bank erosion and turbidity. By design, channels eliminate the hydrological connection to floodplains, and can also severely reduce or eliminate riparian zone vegetation.

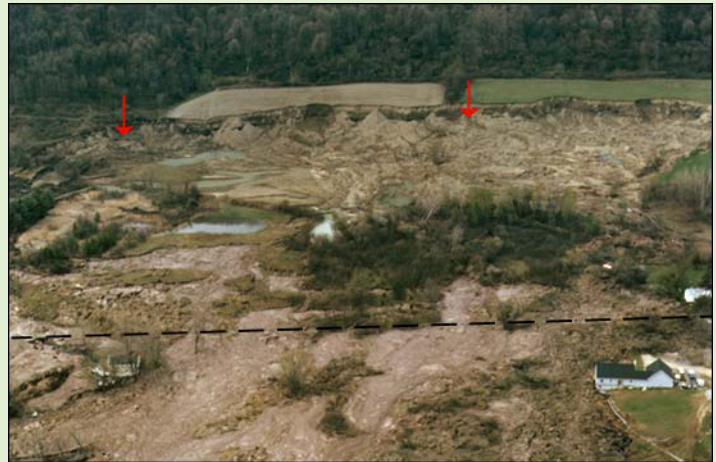
Figure 1: Oblique aerial view of the Tully valley landslide taken April 30, 1993, three days after the slide. Debris moved toward the viewer, in the process covering Tully Farms Road (dashed line) with up to fifteen feet of reddish remolded clay. Three people were rescued by helicopter behind the white house (lower left) from the rapidly advancing landslide. Springs are located between the red arrows.

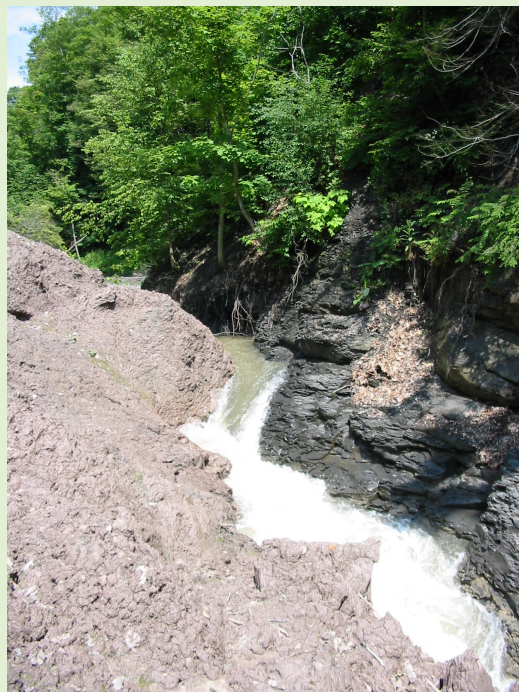
Figure 3

Source: USGS photo of Rattlesnake Gulf, Tully Valley, New York

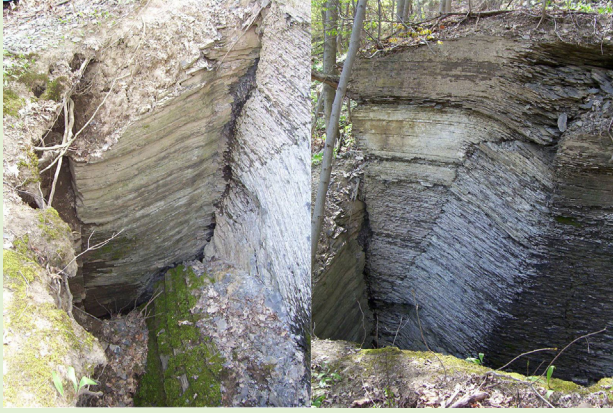
Figure 4

Deformation of rock is visible in the broken and tilted rock layers at Emerson Gulf (Fig. 4).

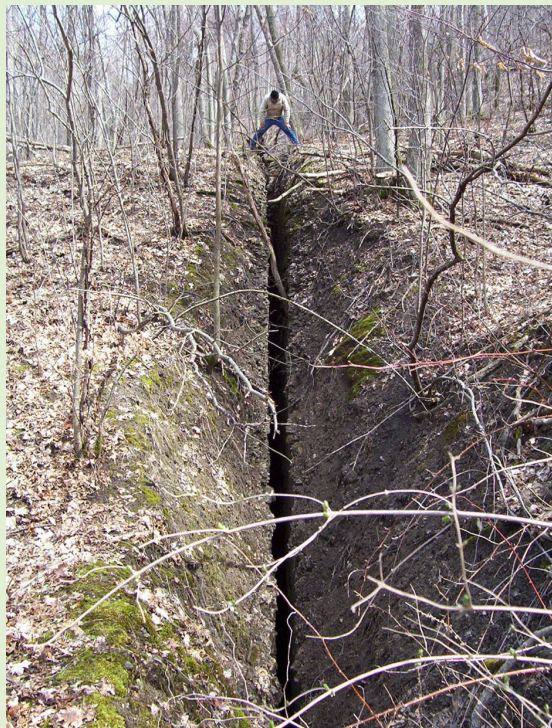
Figure 6

Multiple new bedrock fractures have opened along these joint surfaces in the east and west valley walls (Fig. 6), upslope of the brine field subsidence. These fissures have opened at a rate which can be identified by tree roots that straddle a fissure (Fig. 7). Hydraulic connections may have developed within these 'enhanced' fracture zones and the unconsolidated mudboil aquifer.
